Western Regional Trenchless Review 2021

Keeping Highway 1 Open

Browns Valley Trunk in Napa CA

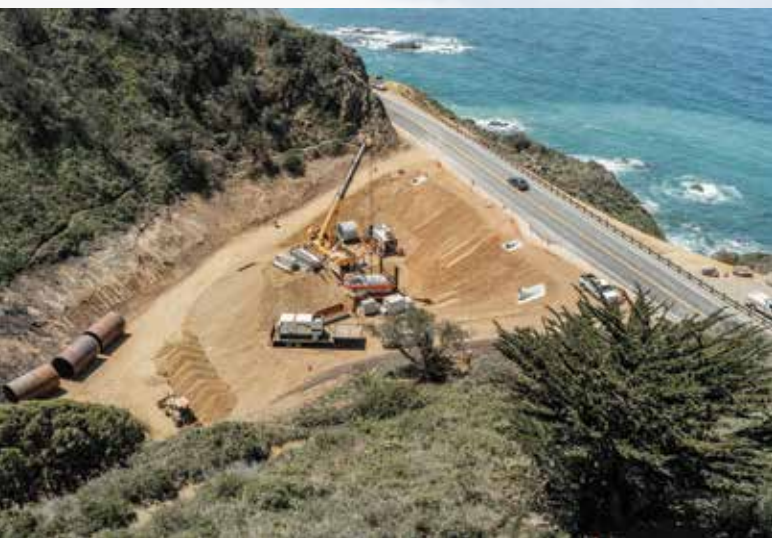
Slope was designed at 30.56 percent downhill which is nearly 80-feet of fall over the 250-foot drive. The culvert was a 1-inch wall steel casing in 16-foot lengths

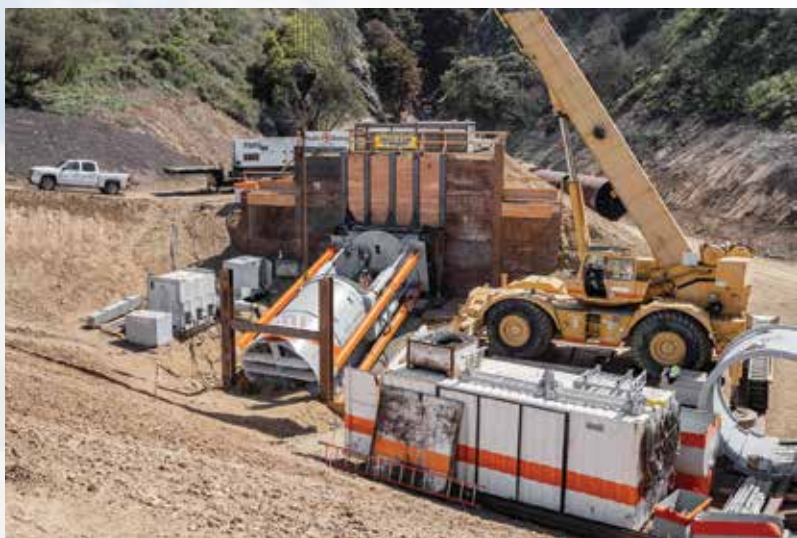
Because the tunnel started inside a depressed basin, there was no jacking pit excavated

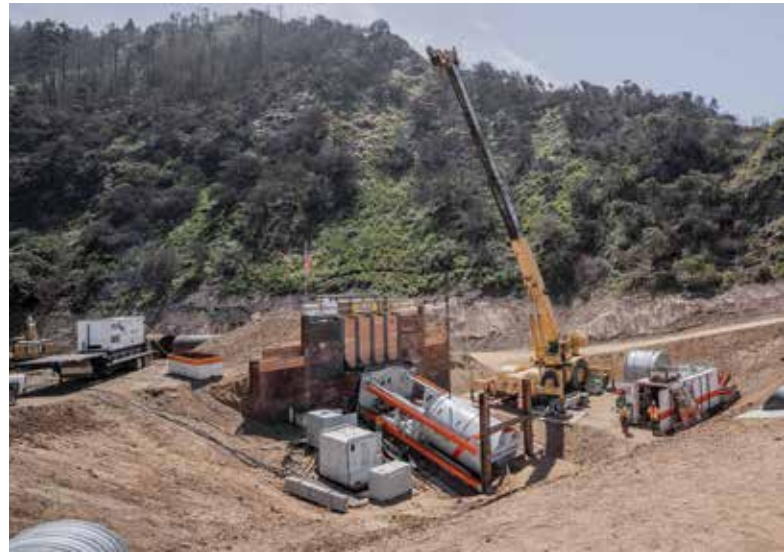
Additional soldier piles were installed at the front of the pit to pin the 800-ton capacity jacking frame back, preventing it from sliding forward as the rams were retracted

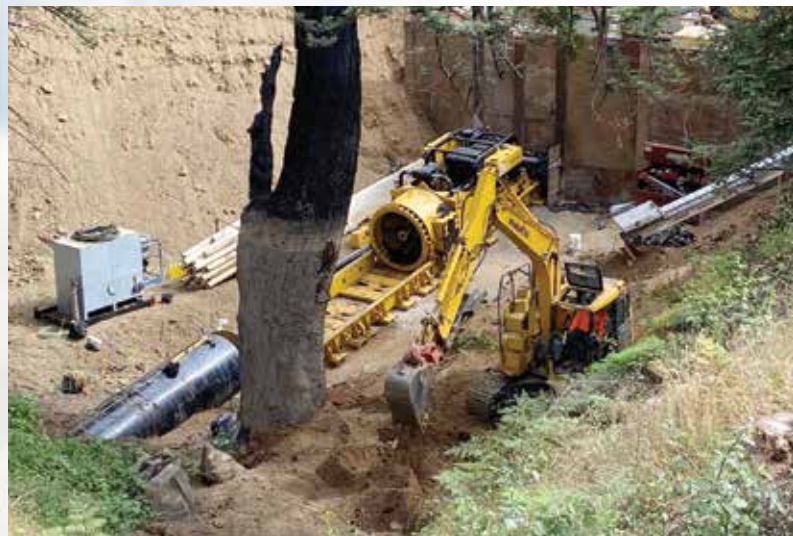
Thrust wall was capable of withstanding an ultimate load of 484-tons

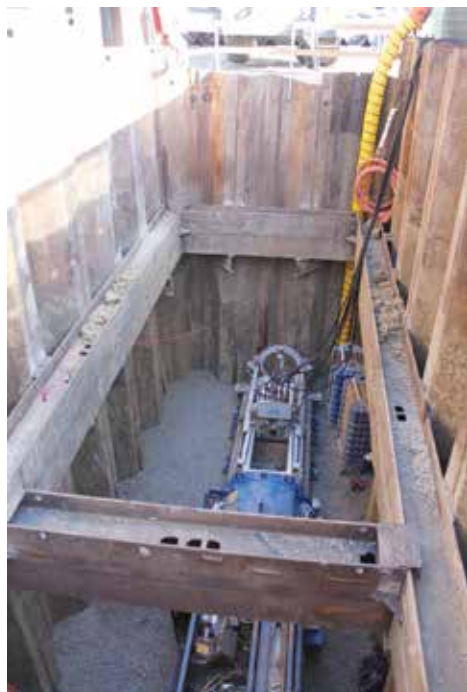
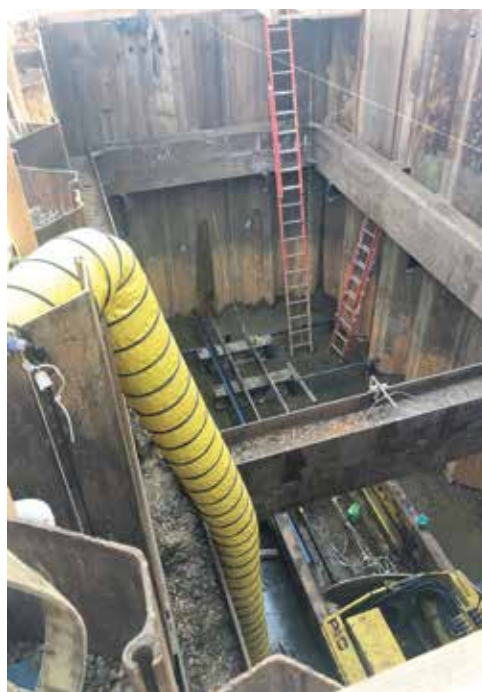
Figure 2. Left: Jacking shaft at Freeway Drive Crossing. Right: Jacking shaft at Highway 29 Crossing

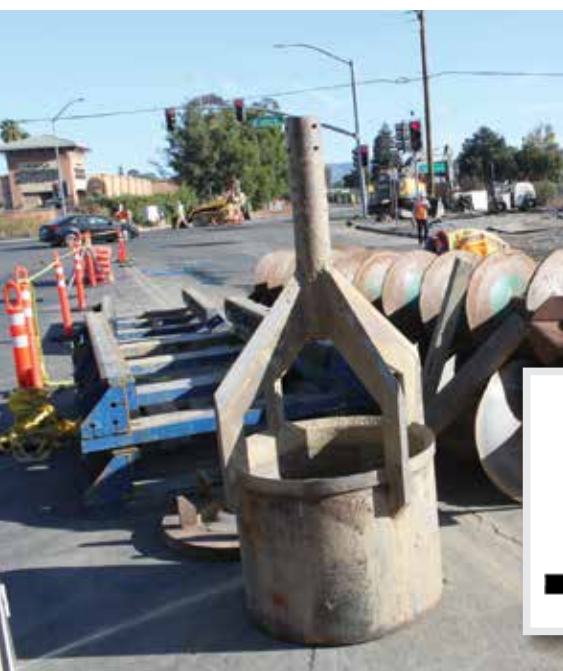
Figure 4. PTGAB reaming head/casing adapter (left) and setup (right)

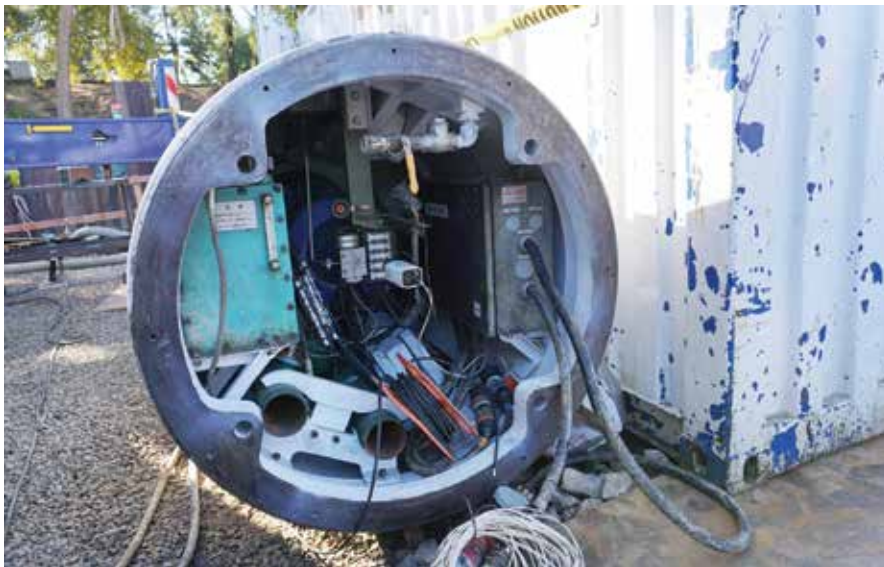
Figure 5. Camera, slurry pipe, water pipe, and target visible in MTBM rear

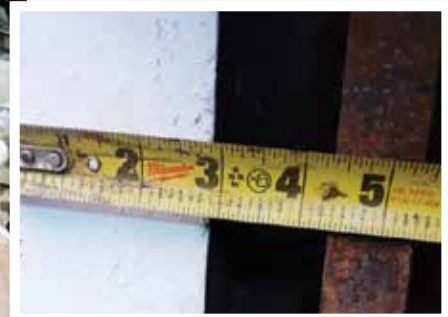
Figure 6. Gusset plates welded to the adapter ring (left); and 1.5-inch gap between the MTBM and the first casing (right)

When the MTBM had reached approximately 56 feet in from the jacking portal, a gap developed between the MTBM and the first casing, with a maximum gap width of 1.5 inches (Figure 6). The alignment at that moment was off by 3.2 inches left of the target center. To close the gap, VTS field-fabricated and welded gusset plates to the adapter ring

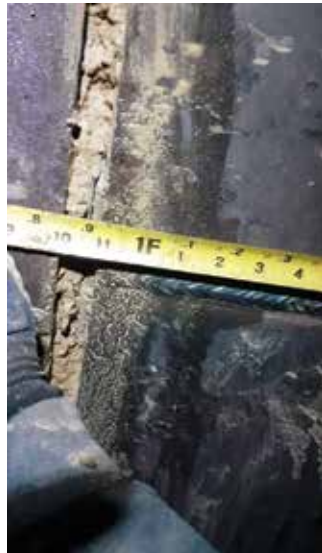
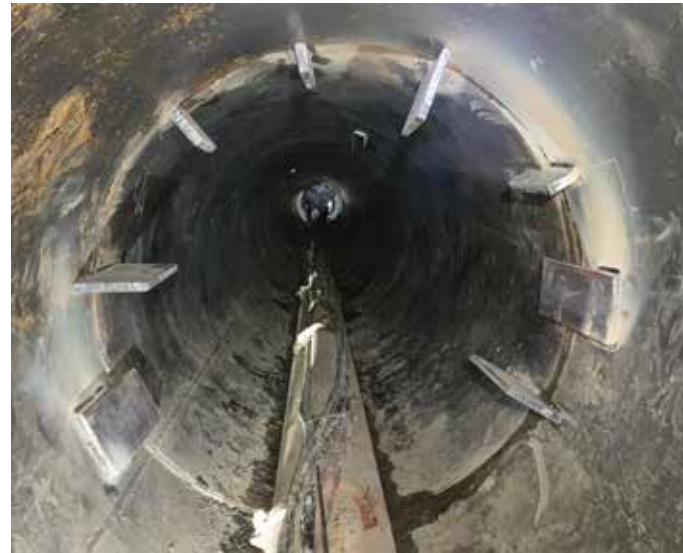
Figure 7. Gaps between casings 5 and 6 (left) and brackets welded between casings 7 and 8 (right)

In addition to the gap between the machine and the first casing, there were three additional weld ruptures between casings (Figure 7). Gaps with a maximum width of 2.5 inches were observed initially, and the number of gaps increased as the MTBM approached the jacking portal. Gaps with a maximum width of 0.7 inch were observed between the casings. VTS field-fabricated and welded brackets between those casings to repair the gaps.

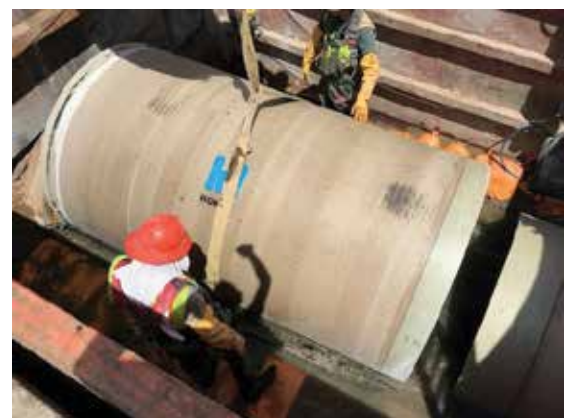
Hobas Slip-line Pipe 72-Inch

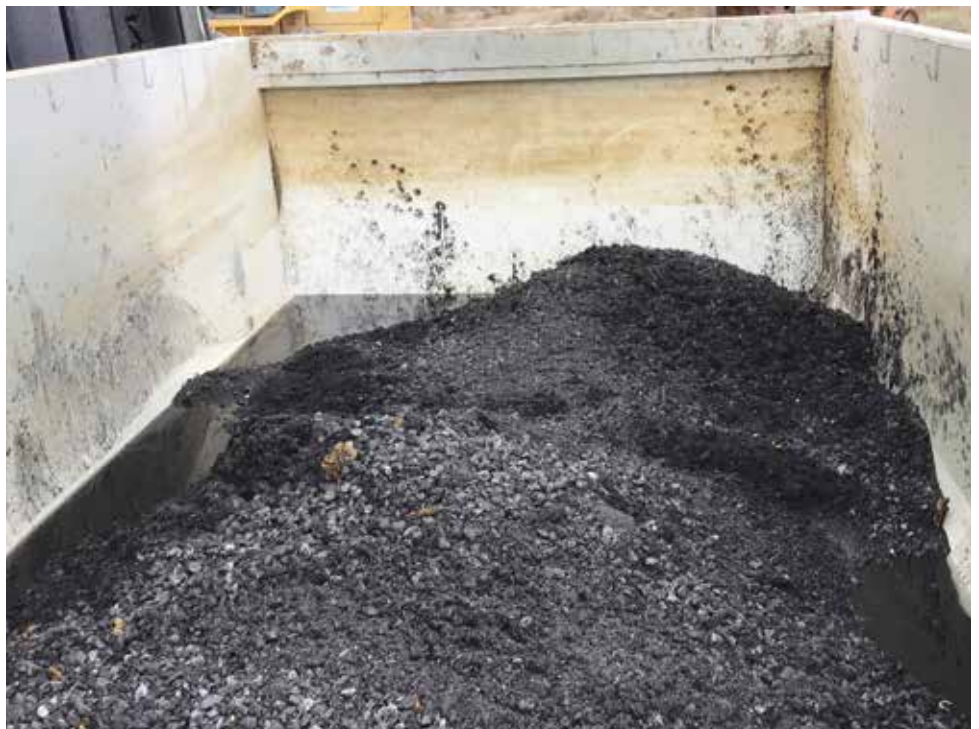
Debris cleaned from sewer. 1202 tons of material was removed!

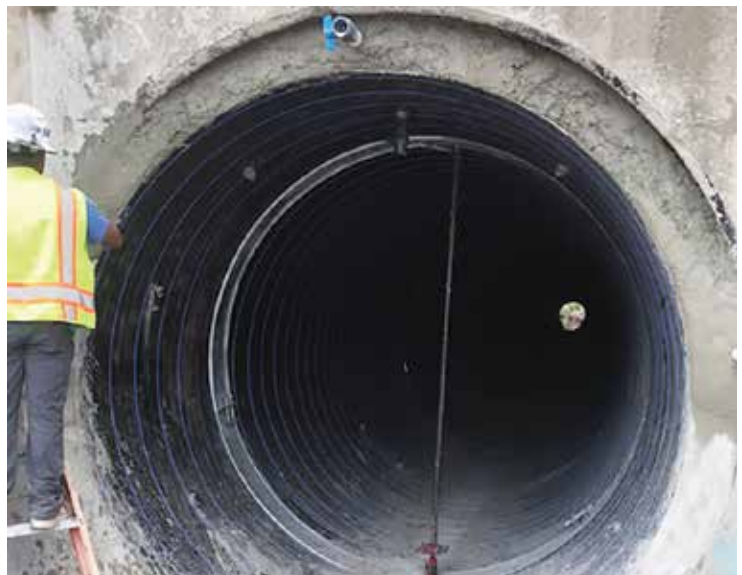
The entire length of the 326 LF culvert was lined with DuroMaxx SRPE liner pipe, providing a long-lasting structural solution

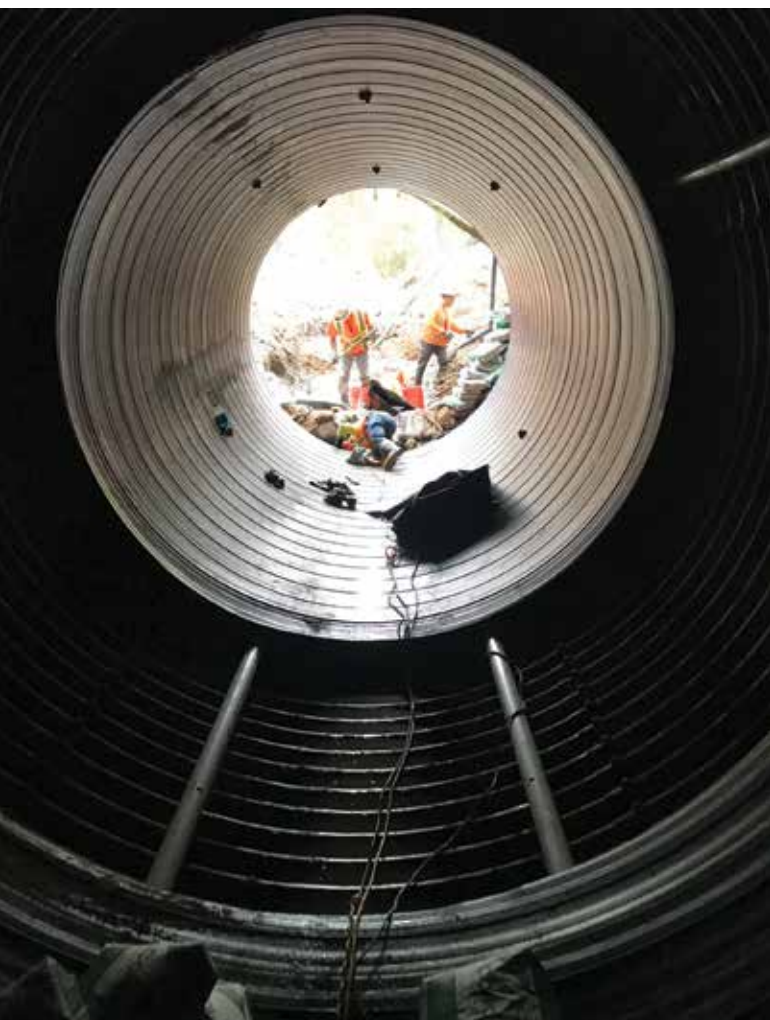
Guide rails ensured proper liner pipe alignment and elevation while decreasing friction during installation

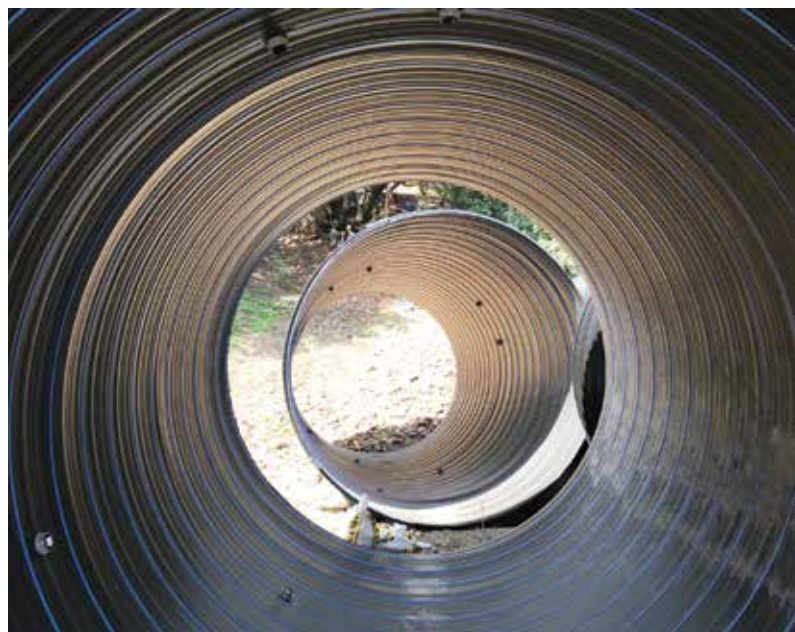
20-foot sections with pre-installed grout ports were shipped from the Ogden UT factory

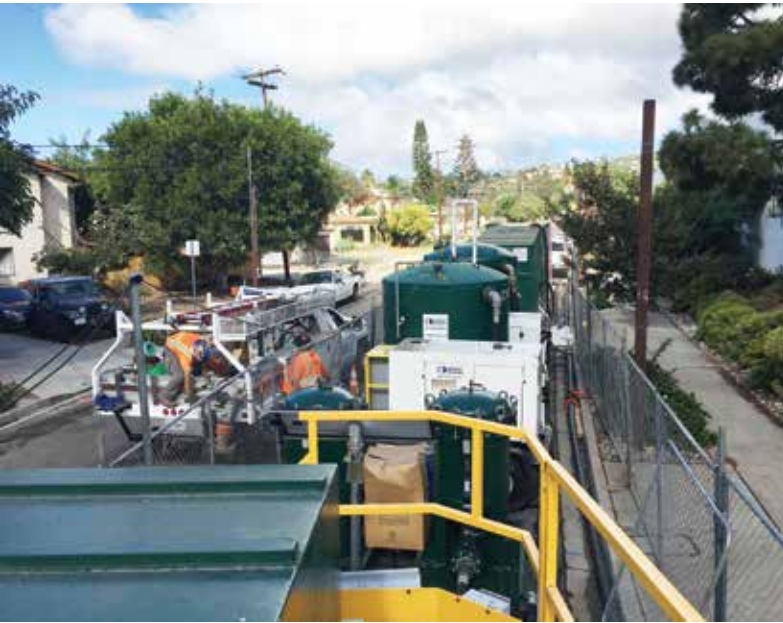
Figure 2. Onsite GAC treatment plant

The rich clays on the project created obstacles for the dewatering filtration and treatment system. The primary issue was clogging of the GAC system. Bag filters were installed to prolong the life of each carbon filter, and bags were replaced one to three times per week with a single change of the GAC filters costing more than \$12,000.

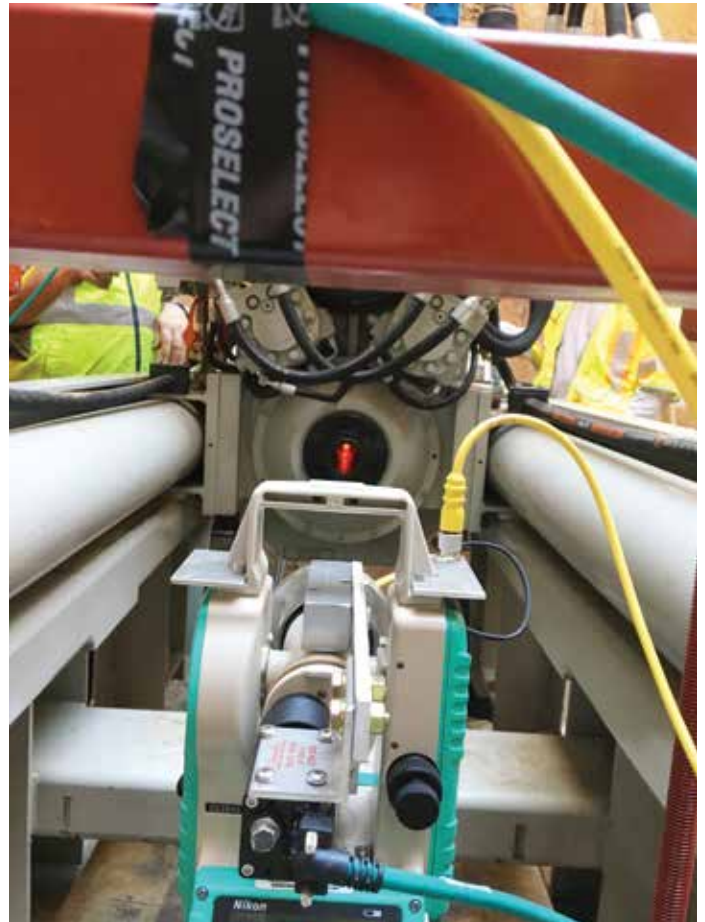
Figure 3. Pilot tube theodolite with integrated camera and visible LED illuminated target

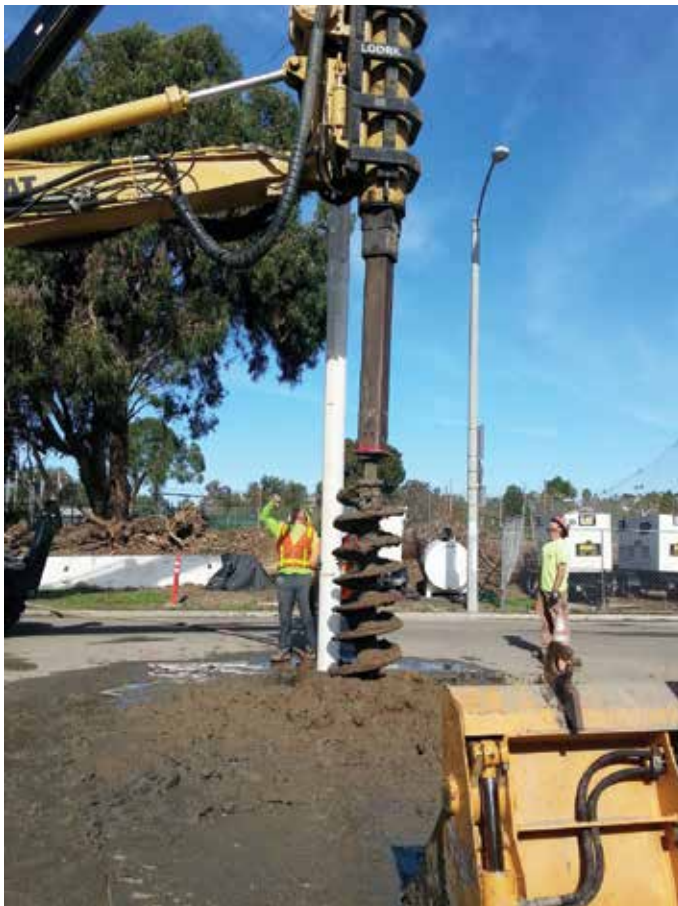
Figure 4. Over 250 wells were drilled at depths ranging from 35 to 40 feet

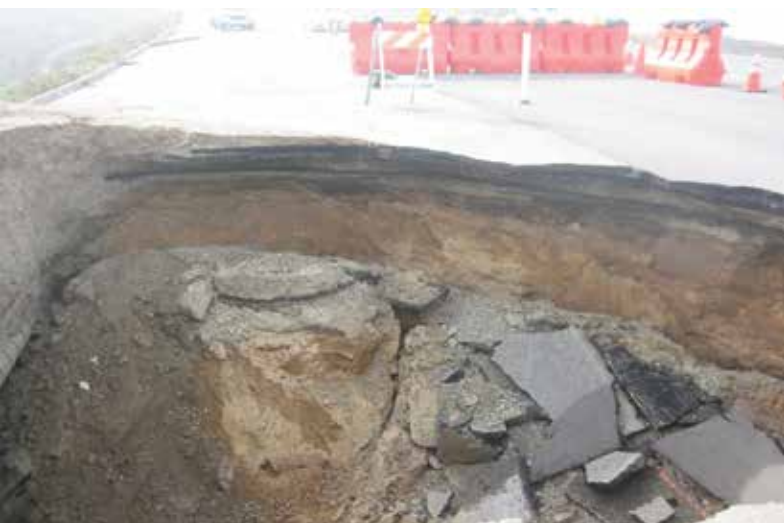
Figure 2. Looking south over sink hole in north bound lane

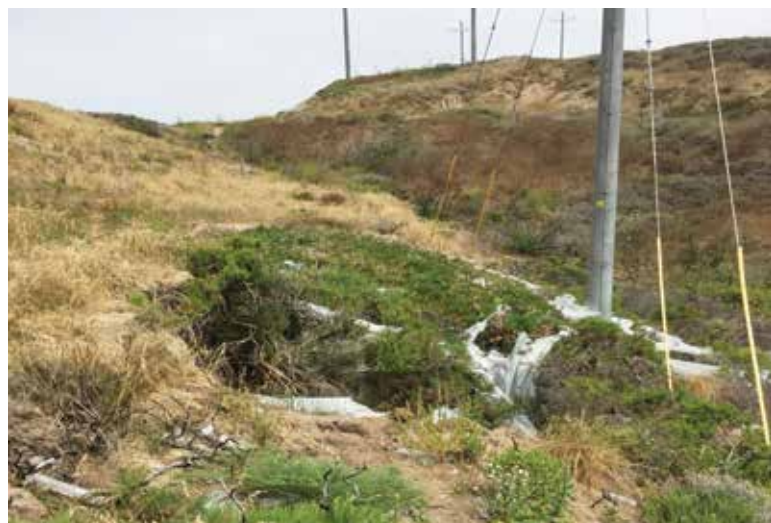
Figure 3. Second sink hole near power pole

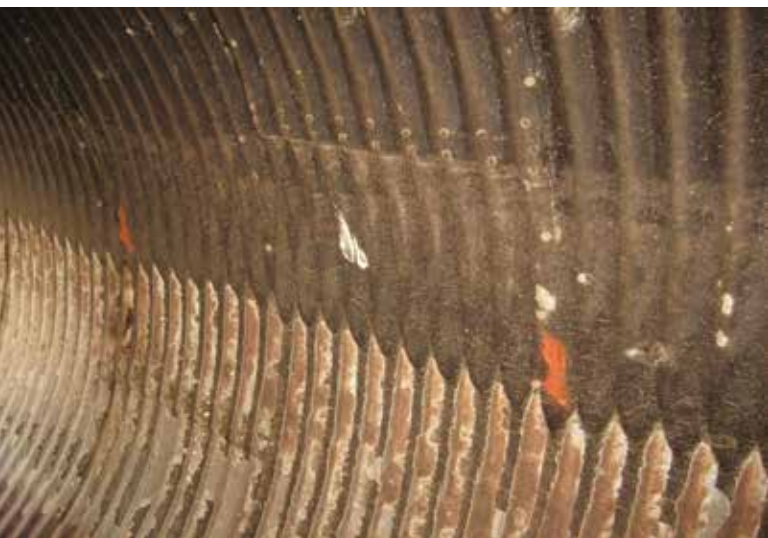
Figure 6. Existing CMP material showing bitumen, zinc, and rivets

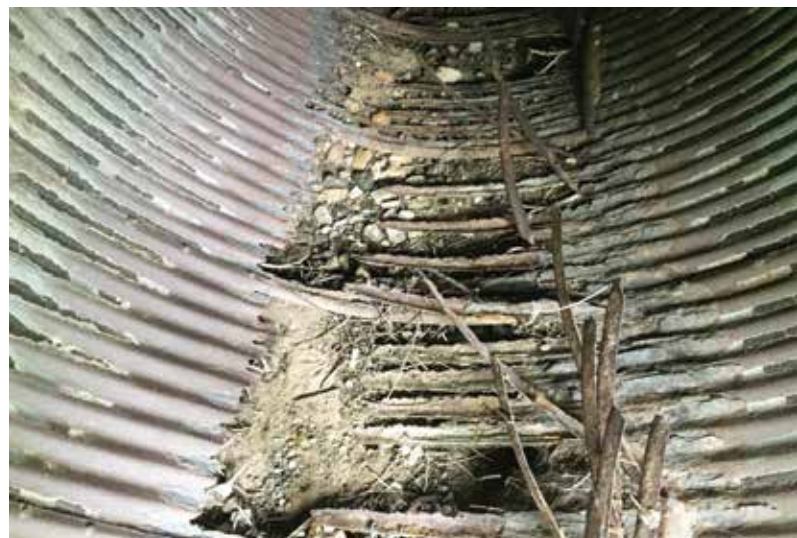
Figure 7. Failed CMP invert before being cast with concrete

7. The culvert invert was cast concrete with two temporary HDPE conduits. The CMP culvert invert failed as shown in Figure 7 below. The invert was cast in concrete as a temporary repair to prevent further erosion during the ongoing wet season. Proposed tunneling method was sized to excavate beyond the concrete cast invert.

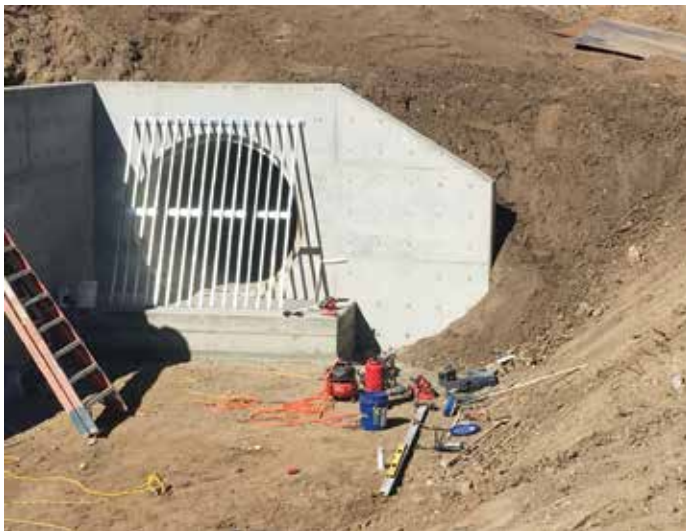
Figure 8. New RCP pipe, headwall, and trash grate before restoration

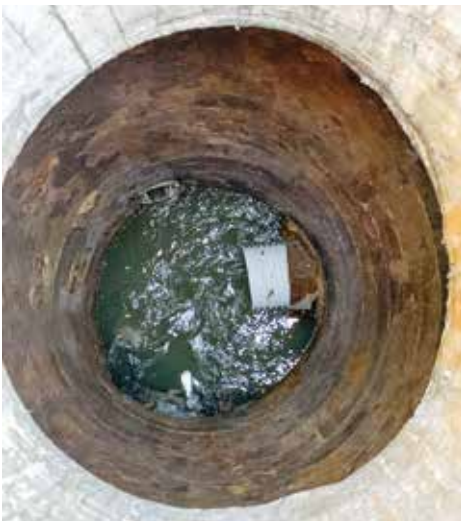
Figure 4. Over 300 linear feet were lined using SPR™EX
